SERIOUS INCIDENT

Aircraft Type and Registration:	BAe ATP, SE-LPS
No & Type of Engines:	2 Pratt and Whitney Canada PW126A turboprop engines
Year of Manufacture:	1991 (Serial no: 2043)
Date & Time (UTC):	9 April 2021 at 0519 hrs
Location:	Ronaldsway Airport, Isle of Man
Type of Flight:	Commercial Air Transport (Cargo)
Persons on Board:	Crew - 2 Passengers - None
Injuries:	Crew - None Passengers - N/A
Nature of Damage:	None reported
Commander's Licence:	Airline Transport Pilot's Licence
Commander's Age:	54 years
Commander's Flying Experience:	5,415 hours (of which 2,964 were on type) Last 90 days - 44 hours Last 28 days - 20 hours
Information Source:	AAIB Field Investigation

Synopsis

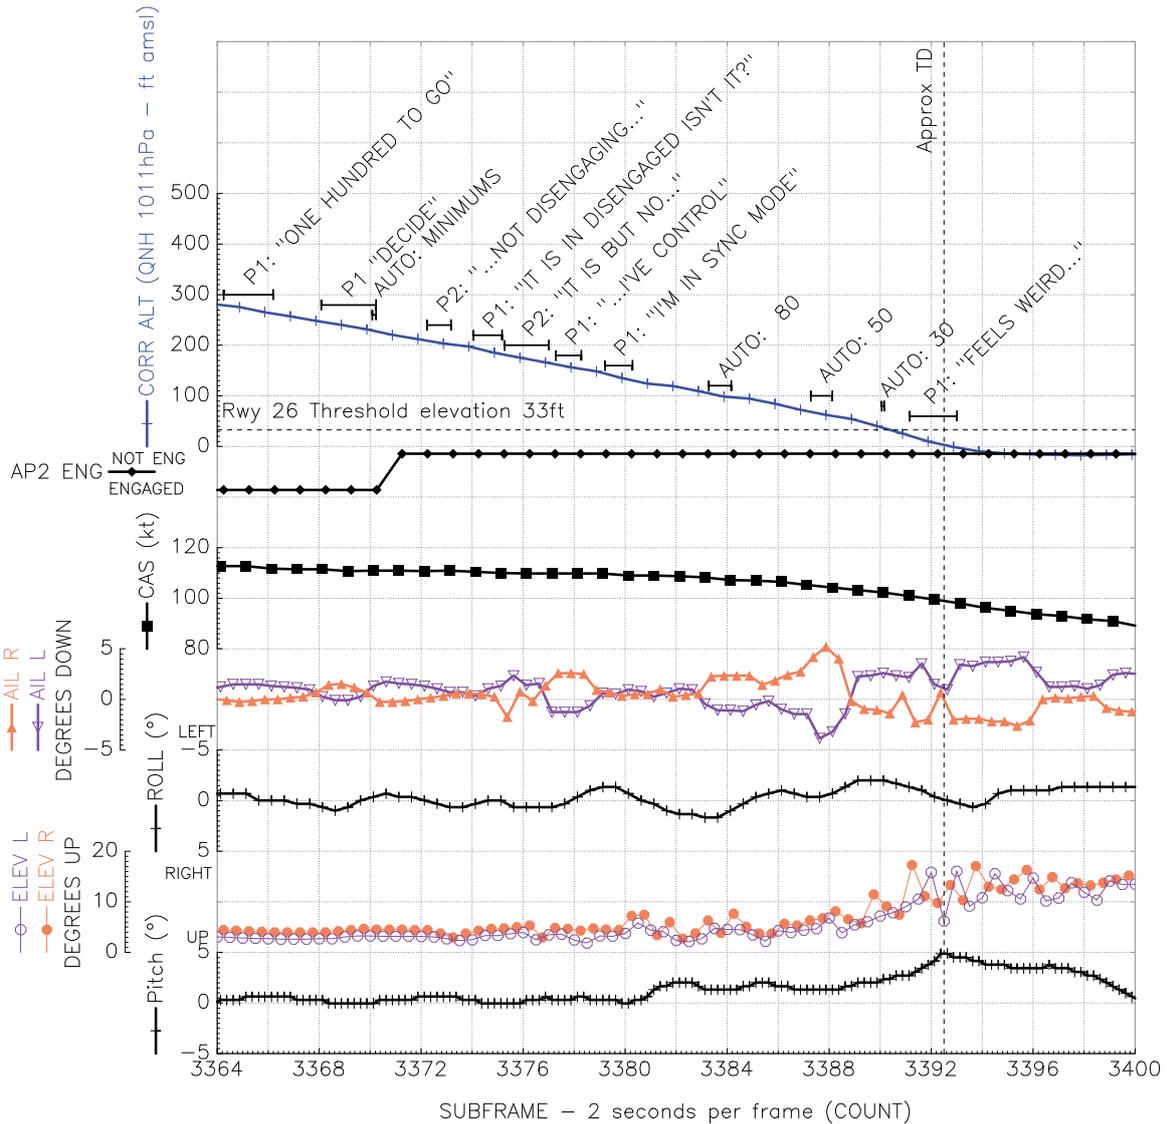
Figure 1
QAR and partial CVR extracts

The co-pilot was the PF during the descent. Passing through 250 ft amsl the commander called "DECIDE" and the automatic "MINIMUMS" call was triggered. The data shows that AP2 disengaged, followed by the co-pilot stating that it was "...NOT DISENGAGING..." No cavalry charge audio, normally associated with an autopilot disengagement, was captured by the CVR. This was followed by a brief discussion between the flight crew, during which the PF commented that he felt the AP had not disengaged. Passing approximately 150 ft amsl, the commander stated that he had control, and that he was "IN SYNC MODE". The descent continued and the aircraft landed normally. The commander stated that the aircraft "FELT WEIRD" but that he was in control.

The only other anomalous system behaviour identified in the recordings were that the altitude alerts recorded by the CVR during the flight were approximately 12 seconds long, which was significantly longer than the expected duration of approximately one second.

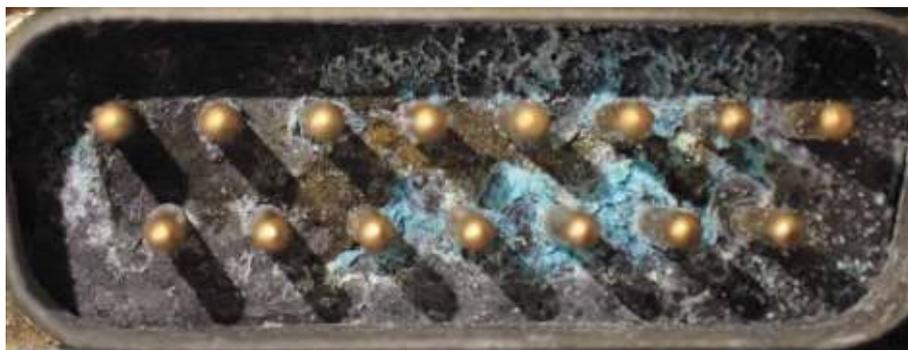
Figure 4

The electrical connector was found to be corroded when the audio warning unit was disconnected (Figure 4). The unit is located in the area beneath the DV window and the operator advised that moisture (water) ingress through the DV windows was a known problem with ATP aircraft.

Contamination and corrosion on the audio warning unit connector

The crew reported anomalies with the altitude alert during the flight and the cavalry charge sounded repeatedly on SE-LPS after it landed; it also sounded repeatedly after the previous flight. The aircraft electrical connector to the audio warning unit was found to be corroded and corrosion was also found inside the warning unit.

- Install the extended side trim panels on all their ATP aircraft and repair any damaged panels.
- Waterproof the side-console switches on all their ATP aircraft.
- Check the rigging of every ATP DV window to make sure that they close correctly.
- Investigate the feasibility of remounting the audio warning unit and installing a drip shield to avoid moisture entering the unit from the top.

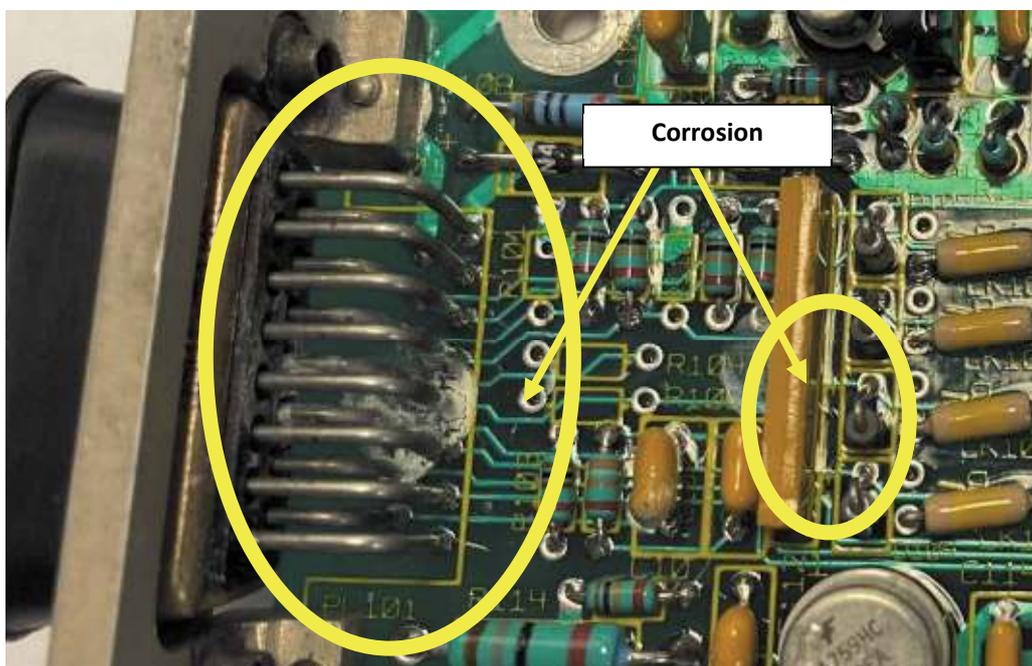
Figure 5

No faults were found when the warning unit was tested. It was dry when disassembled, but corrosion deposits were found on one of the three printed circuit boards (PCBs). Most of

the corrosion was in the area where the external electrical connector was soldered to the PCB, but deposits were also found on other areas of the circuit board (Figure 5).

Corrosion deposits inside the audio warning unit

The investigation concluded that the anomalies with the audio warnings were probably associated with corrosion and moisture caused by water ingress through the DV windows.

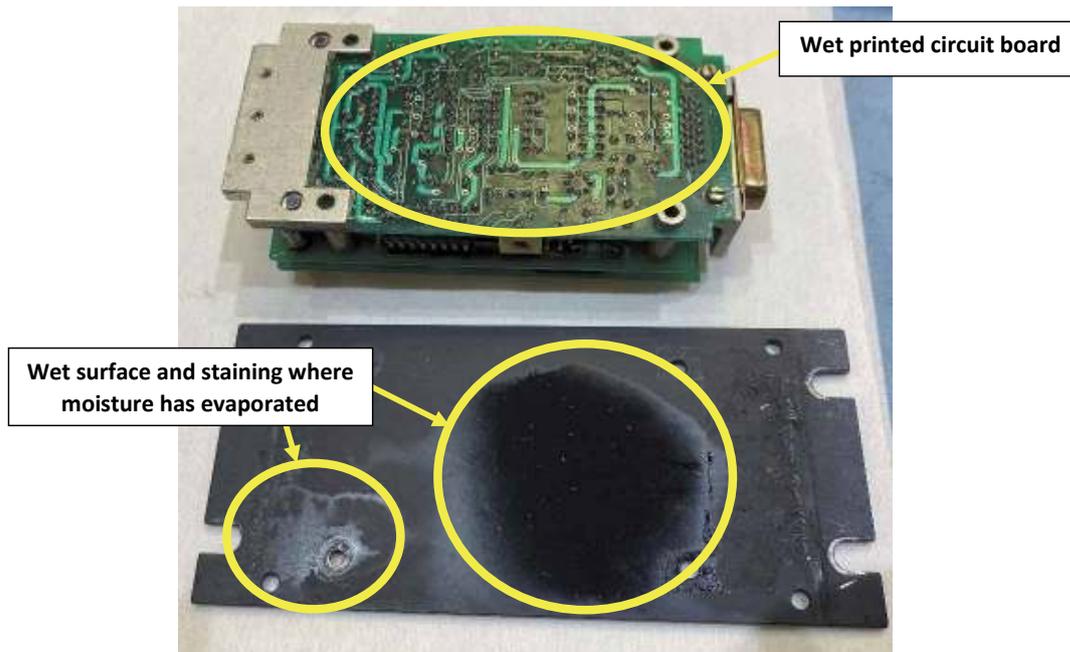
Figure 7

As the audio irregularities on SE-MAJ were very similar to those on SE-LPS, the audio warning unit from SE-MAJ was returned to the AAIB for further investigation. Visual examination found the external condition to be good but when the external cover was removed the internal components were found to be wet and corrosion was seen on one of the PCBs (Figure 7). This examination was carried out seven days after the occurrence of 2 December 2021, so it is possible that the unit had partially dried out in the intervening time.

Visible moisture in the audio warning unit

Corrosion was also found within the warning unit fitted to SE-MAJ and the PCBs inside were wet. The combined effect of the corrosion and moisture cannot be readily assessed. However, given the similarities between the symptoms on both aircraft, it is likely that this contributed to, or caused, the extended duration of the altitude alerts and the repeated cavalry charge warnings on SE-LPS after it landed. The DV windows, which can be opened when the aircraft is on the ground, are known to be susceptible to water ingress. Previous SBs have been issued to reduce the likelihood of aircraft equipment being affected by

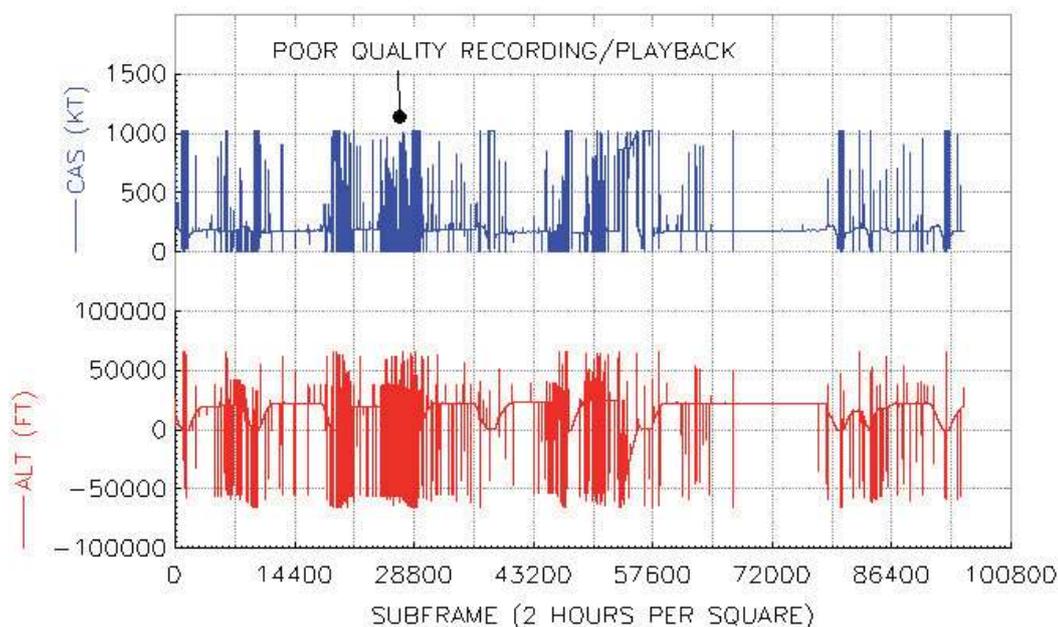
Figure 8

The FDR fitted to SE-LPS was a model PV1584 which records the data on a magnetic tape. These recorders can suffer from quality issues, resulting in parameter error rates that vary throughout the recording (Figure 8). Errors are expected to occur when recorders

stop and start between flights. Additional errors are likely to occur even on a good quality installation.

Example parameters illustrating quality issues of magnetic tape FDR recording from SE-LPS

When reviewing the quality of the recording, it was seen that some periods of the recording had significantly more errors than others. The recorder records the data in six parallel tracks along the tape using six write heads spaced across the tape. When recording and replaying, one read/write head is used for the full length of the tape and then the tape direction is changed and a different read/write head is used for the next pass. Non-uniformity of the quality of the recording is due to differences in the quality of the read/write heads and variations along the magnetic tape. FDR recorder quality checks do not require the whole recording to be checked.

It is recommended that the Civil Aviation Authority review the use of magnetic tape flight data recorders used in aircraft operated by UK Air Operator Certificate holders and establish if there is a practical way to comply with the ICAO requirement to cease their use.

It is recommended that the Civil Aviation Authority require that magnetic tape flight data recorders, used in aircraft operated by UK Air Operator Certificate holders, comply with the Civil Aviation Authority Specification No 10, regarding the error rate requirements, by checking the complete recording rather than by undertaking a sample check.

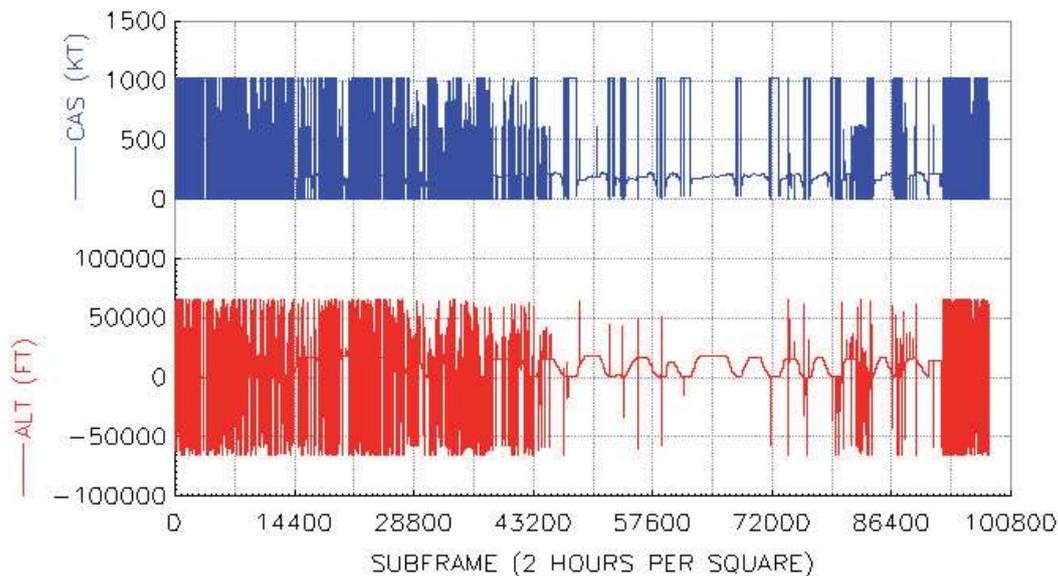
Figure 9

SE-MAJ was also fitted with the same model of FDR as SE-LPS, and the recording from its occurrence flight also had significant quality issues (Figure 9).

Example parameters illustrating quality issues of magnetic tape FDR recording, from SE-MAJ.
