SERIOUS INCIDENT

Aircraft Type and Registration:	BAe ATP, SE-LPS
No & Type of Engines:	2 Pratt and Whitney Canada PW126A turboprop engines
Year of Manufacture:	1991 (Serial no: 2043)
Date & Time (UTC):	9 April 2021 at 0519 hrs
Location:	Ronaldsway Airport, Isle of Man
Type of Flight:	Commercial Air Transport (Cargo)
Persons on Board:	Crew - 2 Passengers - None
Injuries:	Crew - None Passengers - N/A
Nature of Damage:	None reported
Commander's Licence:	Airline Transport Pilot's Licence
Commander's Age:	54 years
Commander's Flying Experience:	5,415 hours (of which 2,964 were on type) Last 90 days - 44 hours Last 28 days - 20 hours
Information Source:	AAIB Field Investigation

Synopsis

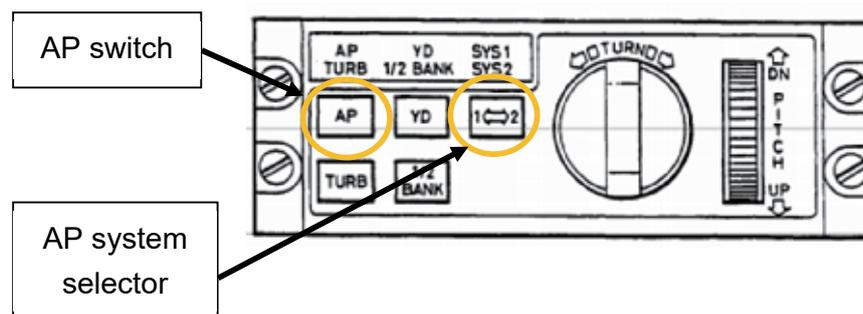
Figure 2

Flight controller © BAE Systems

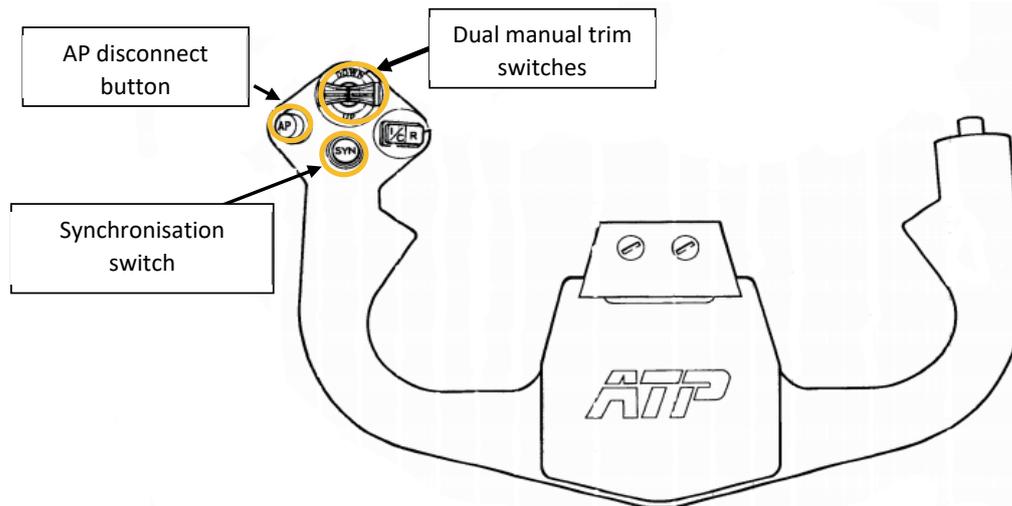
Figure 3

The two aircraft control columns have switches fitted for the control of the autopilot (Figure 3). The co-pilot's control column is similar to the commander's, but with the switches mounted on the opposite side.

Commander's control column © BAE Systems

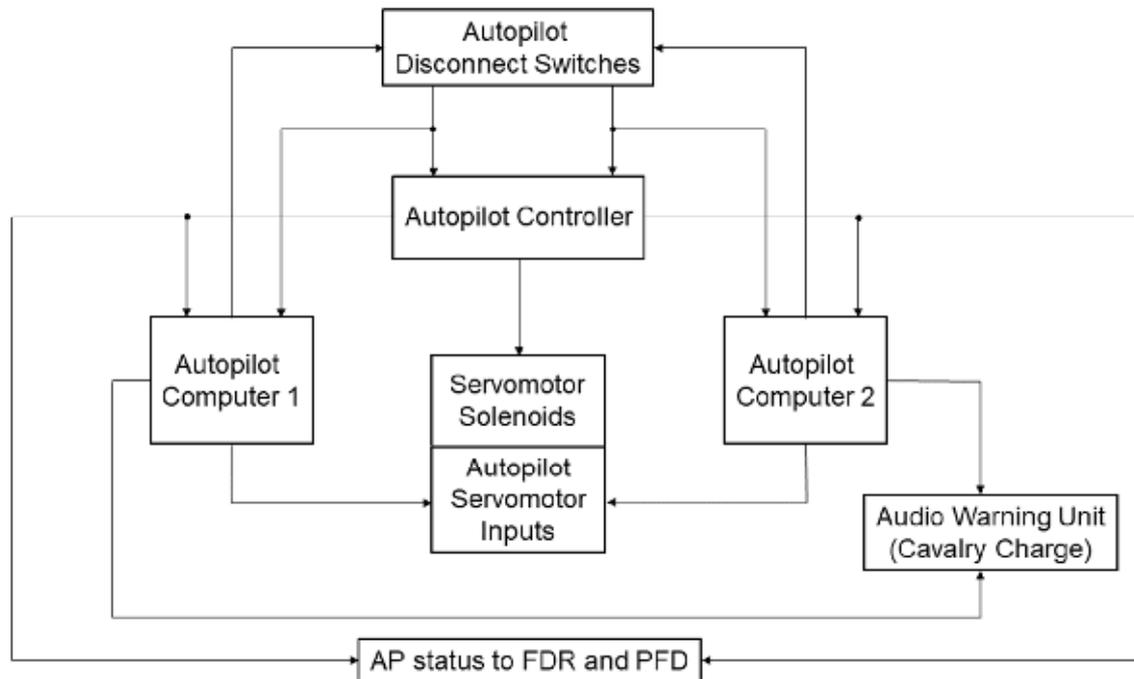
Figure 6

The autopilot disconnect switches are connected to the autopilot controller, which monitors their status and uses analogue logic gates to control the autopilot computers and servo solenoids (Figure 6).

Simplified autopilot schematic (not all components and interactions are depicted)
